**MARINE INVESTIGATION REPORT**  
**M00C0033**

**SINKING AND LOSS OF LIFE**

**PASSENGER VESSEL "TRUE NORTH II"**  
**OFF FLOWERPOT ISLAND,**  
**GEORGIAN BAY, ONTARIO**  
**16 JUNE 2000**

Report Number M00C0033

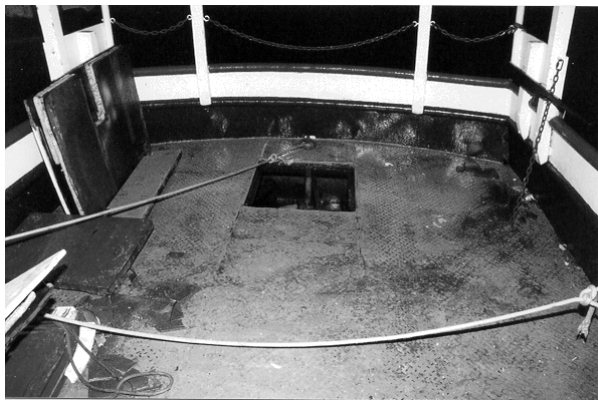
Neither the access hatches nor the main engine casing boundary in the main deck were fitted with watertight gaskets or securing devices. Any water shipped and retained on the main deck was thus allowed to freely enter the underdeck compartment (see photographs 2 and 3).

Photo 2 Aft end of main deck showing intact steel bulwark and hatch opening in main deck with no sealing gasket or means of securing flush wooden cover.

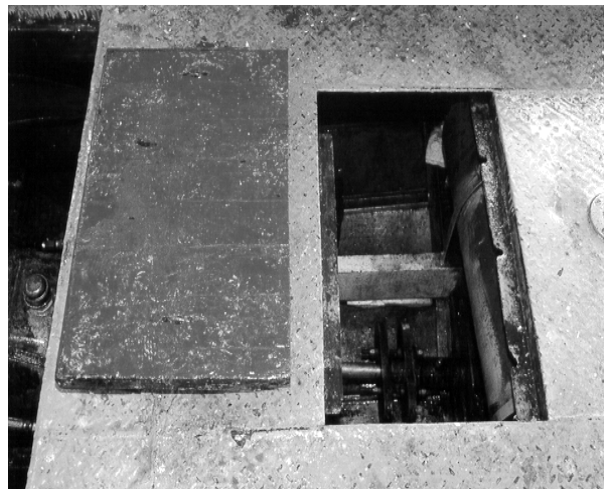
Photo 3 Hatch opening in main deck with no sealing gasket or means of securing flush wooden cover.

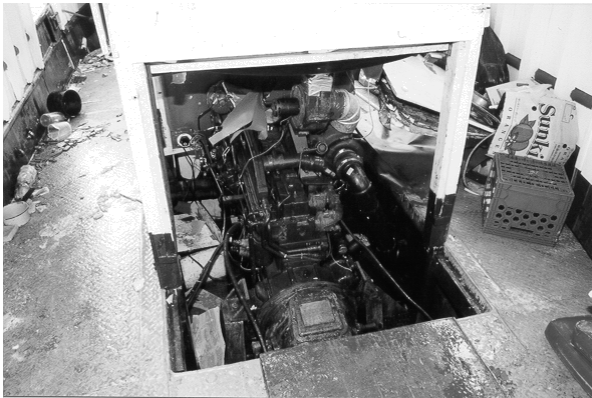
The lower edge of the portable plywood panel forming the after end of the engine casing structure did not extend down to the main deck level, leaving an opening 15 cm by 1.05 m wide across the bottom of the casing end. This opening was provided to enhance ventilation and air supply to the main engine. However, its location at deck level also allowed free entry into the underdeck compartment of any water shipped and retained on the main deck (see photographs 4 and 5).

Photo 4 Opening in main deck with no steel coaming in way of portable plywood panels of engine casing.

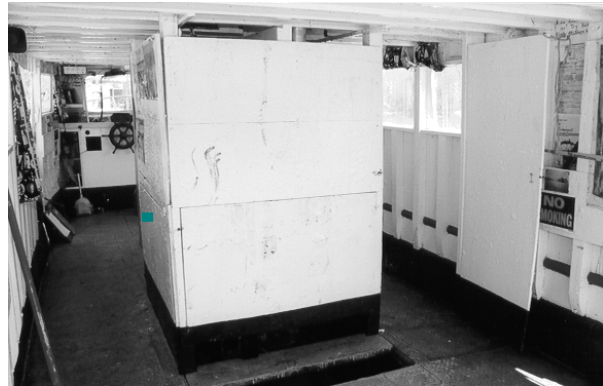
Photo 5 Engine casing with portable plywood panels in place showing opening at aft end for engine ventilation.

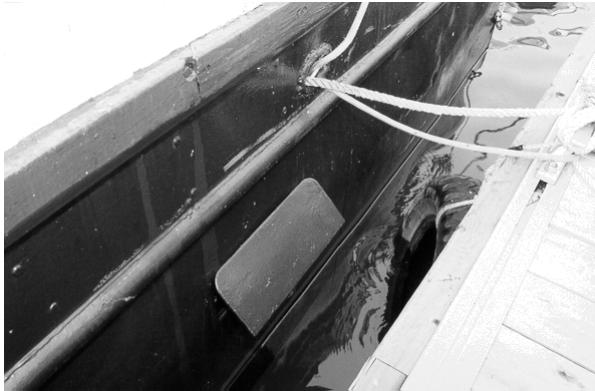
Photo 6 Main deck freeing port in hinged open position.

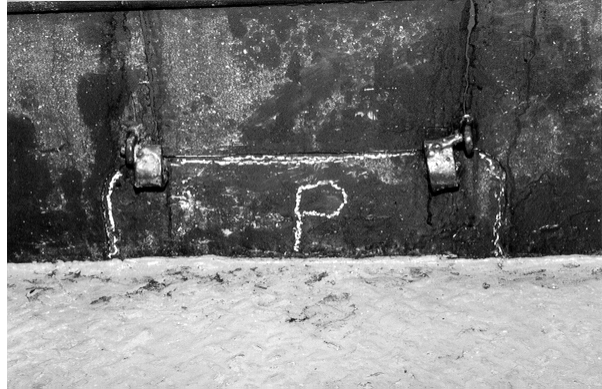
The drainage scupper at the centre of the transom bulwark was found to be effectively sealed shut by a large decal, bearing the vessel's name, that was fixed to the outside of the transom.

This obstruction, in conjunction with the welding-shut of the two freeing ports near midships, reduced the vessel's ability to clear any water shipped on the main deck (see photographs 6 and 7).

Photo 7 Main deck freeing port welded shut. Starboard side is similar.

The clearing of shipped water from the main deck inside the open superstructure was retarded, as two of the four original freeing ports had been welded shut. The shipped water, which was retained on the after end of the main deck, caused the vessel to trim by the stern and also downflooded through non-watertight openings and accumulated in the underdeck compartment.

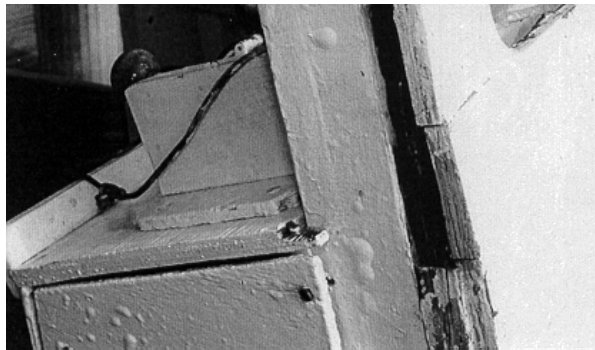
Visual, probing and mallet pounding examinations of the wooden superstructure in general, and the bridge front and its door and door frame in particular, showed areas of significant deterioration due to advanced and incipient rot (see photograph 8).

Photo 8 Disintegration due to dry rot of plywood bridge front in way of front door frame.

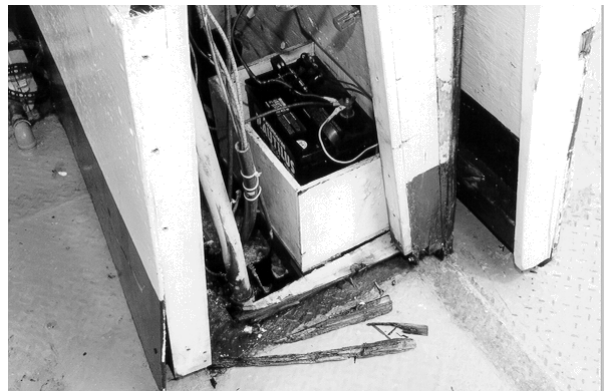
Main deck plating was extensively corroded around the boundary of an irregularly shaped opening that provided access to the main engine control, steering gear and electrical cables inside the wooden console at the steering position. This opening allowed any water shipped and retained on the main deck to freely enter the underdeck compartment.

The wooden framing of the bridge front, console and door frame was discoloured and softened by decay, and the lower ends were partially disintegrated (see photograph 9).

Photo 9 Disintegration due to dry rot of door frame and console base, and corrosion in way of irregularly shaped hole in main deck.

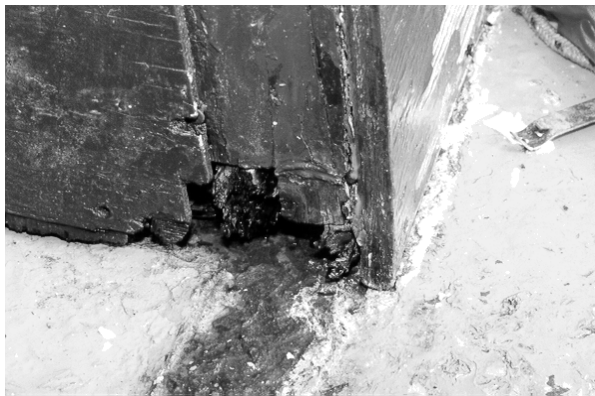
The deteriorated condition of the inboard edge of the wooden frame in way of two of the three hinges of the bridge front door was such that the holding power of the 25 mm long screw fastenings was markedly reduced. The timber and wood packing in way of the hinge screw holes was decayed such that the screws were pulled clear with the door. The third and lowest door hinge remained attached to the door frame, and its screw fastenings were pulled clear from the door itself.

The 20 mm by 20 mm wooden door stop and its nail fastenings to the framing at the door's outboard edge (which were found to have been bent backwards through 90 degrees), extended down from the top of the door frame to within some 350 mm of the deck and consequently did not provide any support to the lower area of the door.

Photo 10 Disintegration due to dry rot of inboard base of bridge front door frame (outboard base similar).

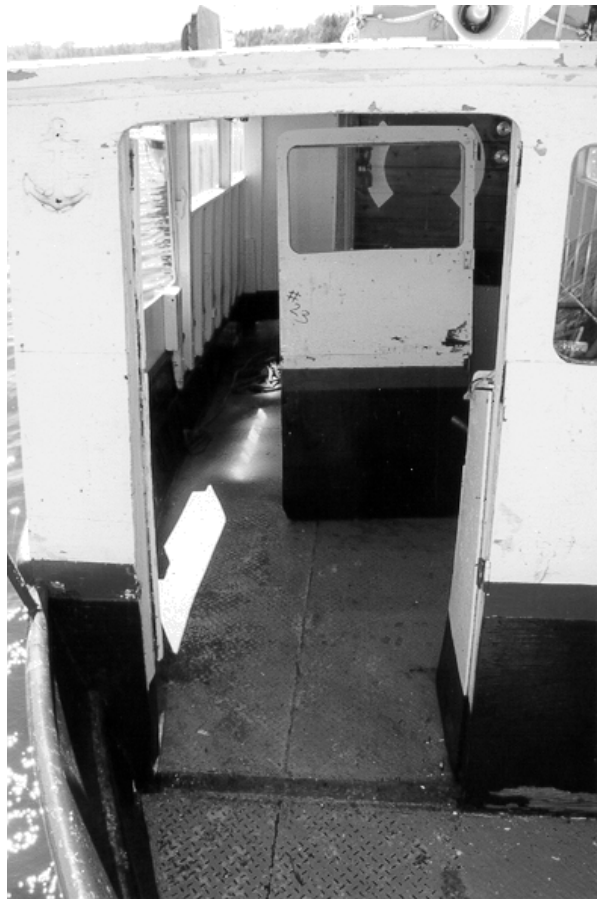
The 63 mm by 63 mm thick wooden door stop, forming a sill across the bottom of the door, had been unbolted and removed for repair the day before the occurrence. The sill had been replaced without its bolted connection, which reduced support to the lower area of the bridge front door (see photographs 10 and 11).

Photo 11 Opening in bridge front with stove-in door forced inside superstructure and unpainted, corroded foot print on main deck of missing door sill.

- The wood door stop and all securing bolts at the bottom of the bridge front door opening were missing, and the retaining stop at the outboard side of the door frame was bent aft through 90 degrees.

The deteriorated condition of the bridge front and its wooden framing in way of the door and window frames and the reduced support in the lower area of the door were such that, in the event, the bridge front door and window were unable to withstand the forces imposed on them.

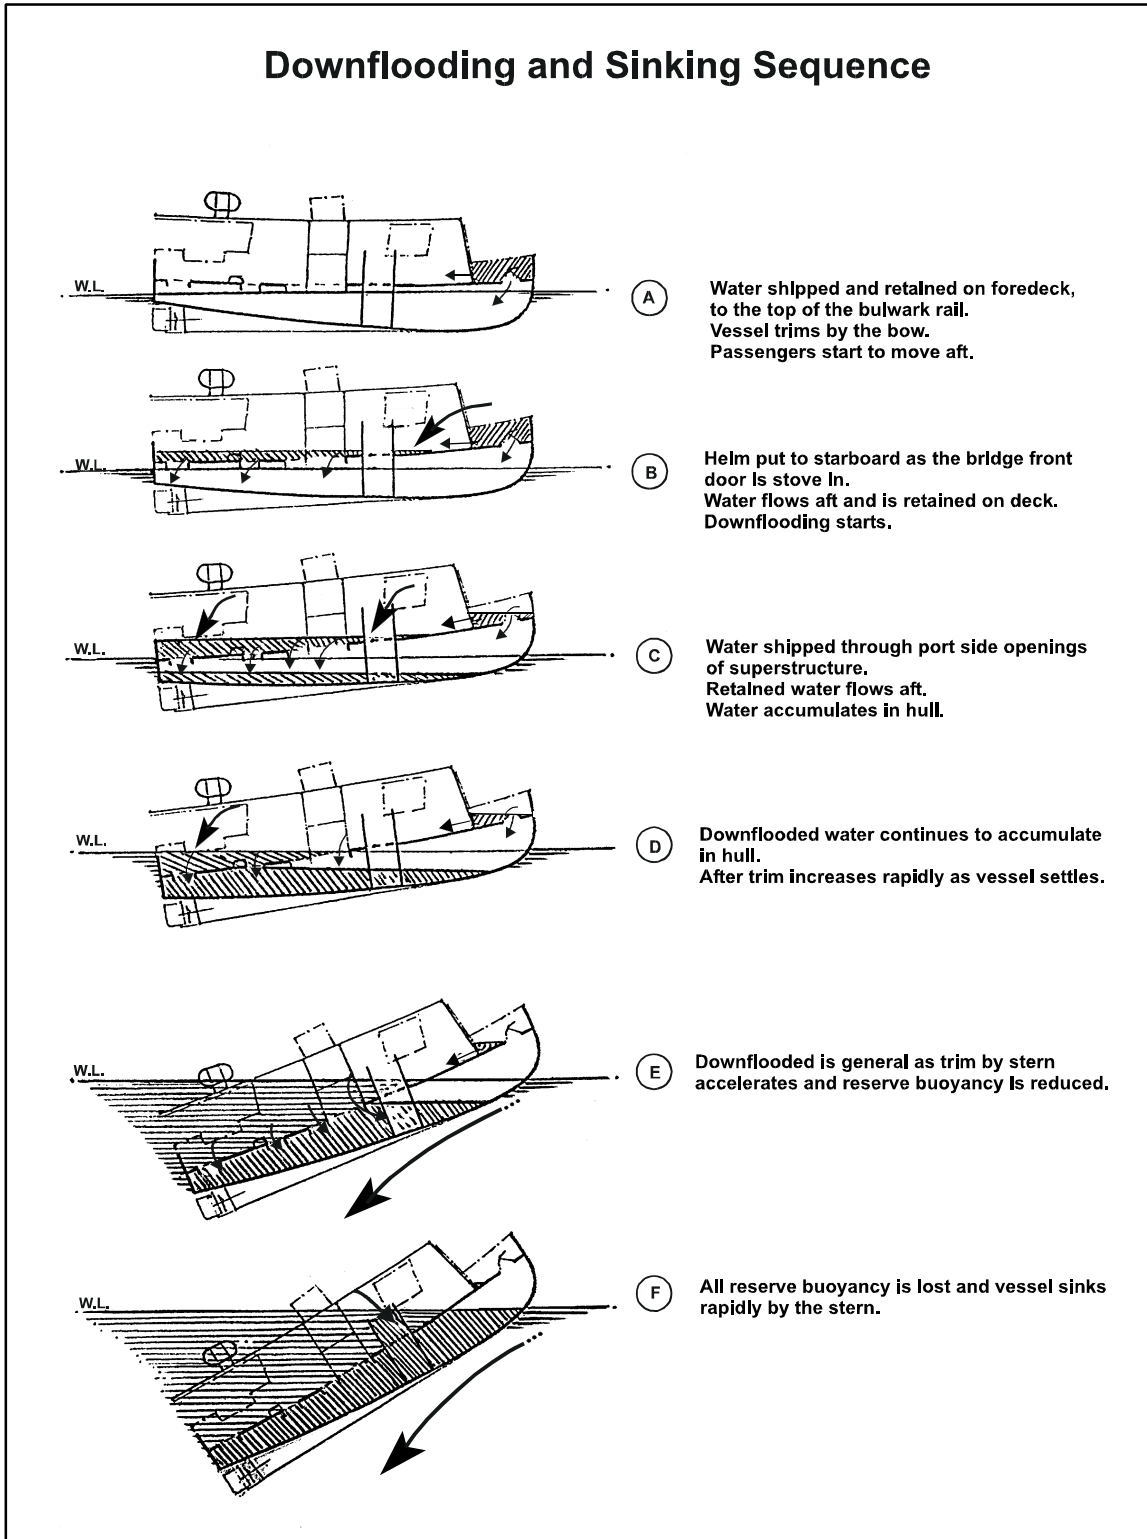
Figure 2

Rolling and heeling effects, imparted by wave motions while the vessel was trimmed by the stern and sinking, preclude a precise determination of the many trimmed attitudes the vessel could have taken. However, based on the reported sequence of events, the chronology of the occurrence—from the initial shipping of water over the bow to the subsequent sinking—can be determined, and is illustrated in Figure 2.

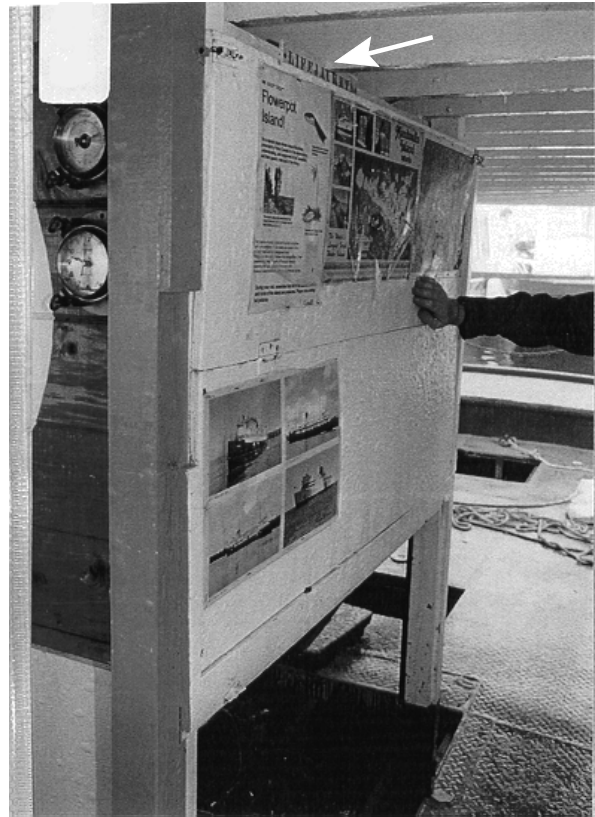
Photo 12 Lifejacket locker in engine casing with door in closed position showing LIFEJACKETS sign (arrow) and posters on door

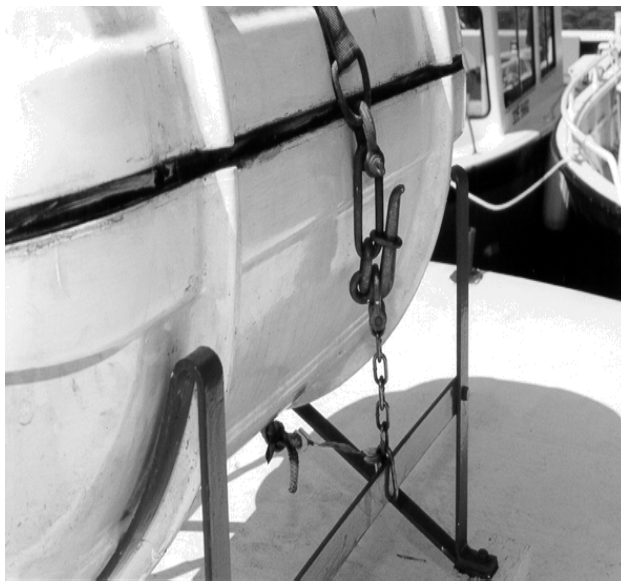
In 1997, following discussions with TCMS inspectors, the vessel was equipped with an inflatable liferaft. A 20-person Dunlop-Beaufort liferaft was installed in a cradle located on top and at the after end of the wooden superstructure. It was secured by a nylon lashing, which was attached to the cradle by a shackle at one end of the lashing and by a Senhouse slip at the other end. Such a securing arrangement requires human intervention for the launching. The master did not have ready access to the liferaft, as there was no means, such as a ladder, to climb atop the superstructure where it was stowed. Its installation on the vessel was accepted by TCMS inspectors (see photograph 13).

Photo 13 Manual release Senhouse slip securing inflatable liferaft in cradle on superstructure top.

After being washed out of the vessel, the master swam on top of the superstructure but did not reach the inflatable liferaft in time to release it before it sank with the vessel. Since 1978, safety requirements provide for either deep chocks or a hydrostatic release unit to allow the liferaft to float free. Without the benefit of a liferaft, passengers were immersed in the cold water for up to 50 minutes as they clung to the buoyant apparatus; this increased their risk of hypothermia and drowning.
